**Flood Control Project Maintenance
Levee Inspections**
LMA District Cover Sheet
Spring 2019 Levee Inspection Results

Reclamation District No. 0108 River Farms

Levee Inspection Report By Mile - Spring 2019

Waterway	Bank	Unit Miles	Inspection Start/End	Inspector
Unit No. 01 Colusa Basin Drain	Left	20.64	04/03/2019 04/03/2019	Zach Jojola

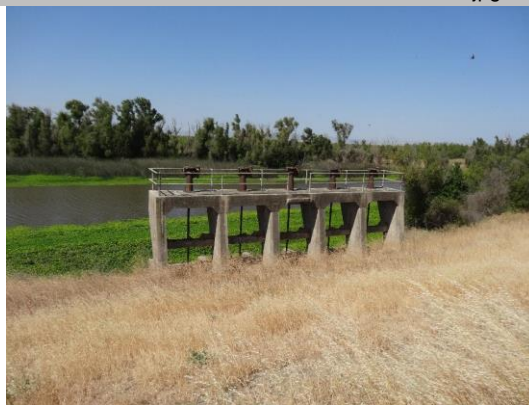
Photo 2 of 3 : UCIP_SP_2019_37610_68219.jpg

Dense vegetation covers waterward side slope.

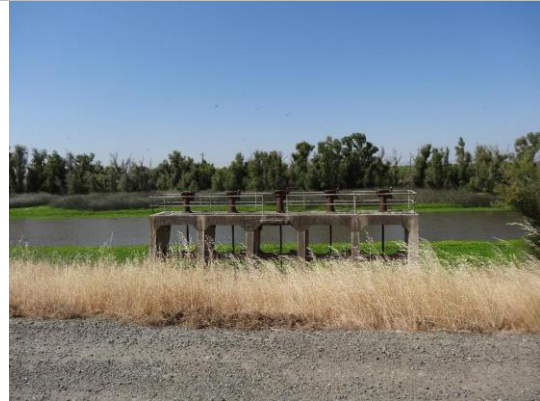
Photo 1 of 3 : UCIP_SP_2019_37611_68220.jpg

Comment Code					
Inspector Comment					
FS_ID:37611 DS_ID:22388 EP_NO: 9396 Repair Type: Non-Urgent Crossing Status: Found UCIP Comments: Need to contact owner to determine status of structure. Notes indicate crossing has been abandoned. Owner will need to coordinate with CVFPB and DWR inspector to determine how to properly abandon. FIELD_STRUCT_DESC: *ABANDONED* 4 of 5: 72-inch reinforced concrete gravity drainage pipe or culvert through the levee, 31.6 feet below the crown. Slide gate on each end. (Retention of five 72-inch pipes through the levee [HLM 0.08] authorized under Automatic Board Order (ABO) issued as Permit No. 9736, 1974 - Reclamation District No. 108 [RD0108]). [Additional Reference(s): DWR Levee Log, 1991. USACE Sacramento O&M Manual 132, October 1959, (HLM 0.08), referenced as five 6-foot by 8-foot concrete drainage culverts]. FS Date: 6/10/2014

Concrete structure located on waterward side.

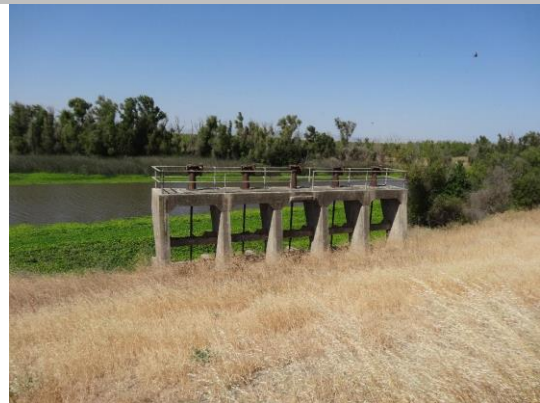
Photo 2 of 3 : UCIP_SP_2019_37611_68224.jpg

Waterward slope covered by dense vegetation.

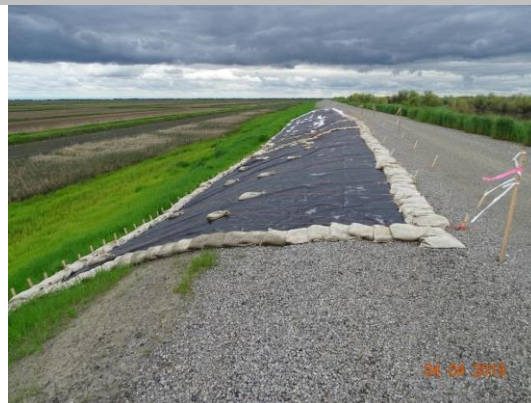
Photo 1 of 1 : SP_2019_RD0108_203_17_20190404_00030.jpg

LM Start	1.49	Rating **	M	Issue No.	17
LM End	1.51	Issue Type +	Ma	Location *	LS
Category	Earthen Levee			GPS Latitude/Longitude	
				Start	End
Item	Slope Stability			38.830951 °	38.831043 °
				-121.821574 °	-121.821847 °
DWR ID	DWR_RD0108_01_s_2019_17				
Comment Code					
S1 : Repair slope instability.					
Inspector Comment					
Sloughing occurred on the landside slope. LMA placed a raincoat over the issue.

View of the sloughing on the landside slope. Spring 2019.

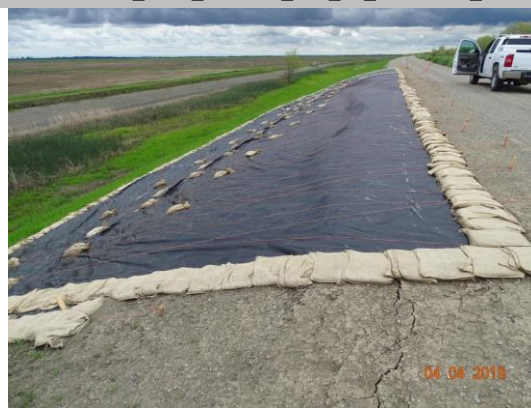
Photo 1 of 1 : SP_2019_RD0108_203_15_20190404_00029.jpg

LM Start	2.72	Rating **	M	Issue No.	15
LM End	2.72	Issue Type +	Ma	Location *	LS
Category	Earthen Levee			GPS Latitude/Longitude	
				Start	End
Item	Slope Stability			38.837714 °	38.837714 °
				-121.842602 °	-121.842602 °
DWR ID	DWR_RD0108_01_s_2019_15				
Comment Code					
S1 : Repair slope instability.					
Inspector Comment					
Sloughing occurred on landside slope. LMA has placed raincoat over the issue.

View of sloughing on the landside slope. Spring 2019.

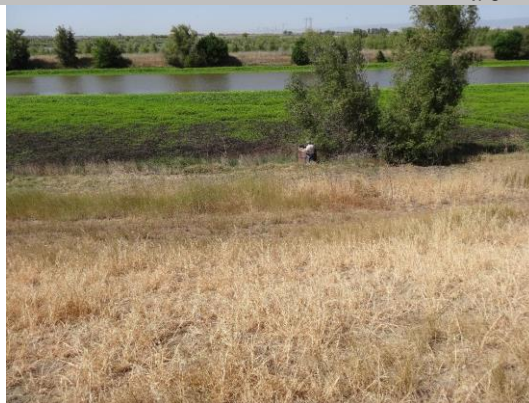
Photo 1 of 3 : UCIP_SP_2019_39707_71682.jpg

Comment Code					
Inspector Comment					
FS_ID:39707 DS_ID:24875 EP_NO: N/A Repair Type: Non-Urgent Crossing Status: Indicator Found UCIP Comments: No signs of pipe visible--need to contact owner to obtain permit number authorizing work. If crossing is no longer used by owner, the owner will need to coordinate with DWR Inspector and CVFPB to remove crossing according to Title 23 requirements. Dense vegetation limits the inspector's visibility to identify signs of pipe failure (leaks) along the slope. Recommend removing vegetation along pipe alignment to conduct proper inspection of structure. FIELD_STRUCT_DESC: Corrugated metal pipe (CMP) riser on the waterside (WS). Riser is filled with trash and debris. Unable to determine if a crossing exists at this location. This riser was field discovered. FS Date: 3/18/2014

View of waterward side.

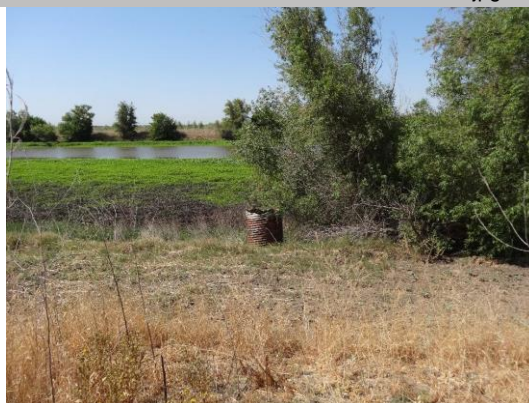
Photo 2 of 3 : UCIP_SP_2019_39707_71681.jpg

CMP riser located on waterward toe--2/3 filled with soil and trash.

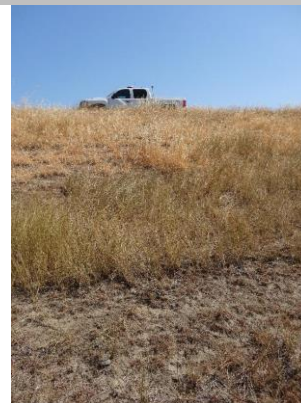
Photo 3 of 3 : UCIP_SP_2019_39707_71680.jpg

Comment Code						
Inspector Comment						
FS_ID:39707						
DS_ID:24875						
EP_NO: N/A						
Repair Type: Non-Urgent						
Crossing Status: Indicator Found						
UCIP Comments: No signs of pipe visible--need to contact owner to obtain permit number authorizing work. If crossing is no longer used by owner, the owner will need to coordinate with DWR Inspector and CVFPB to remove crossing according to Title 23 requirements. Dense vegetation limits the inspector's visibility to identify signs of pipe failure (leaks) along the slope. Recommend removing vegetation along pipe alignment to conduct proper inspection of structure.						
FIELD_STRUCT_DESC: Corrugated metal pipe (CMP) riser on the waterside (WS). Riser is filled with trash and debris. Unable to determine if a crossing exists at this location. This riser was field discovered.						
FS Date: 3/18/2014

View of waterward slope.

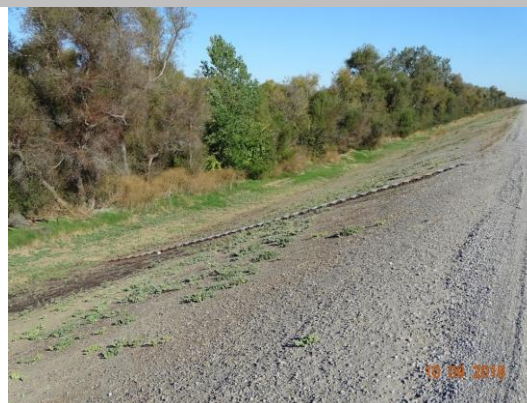
Photo 1 of 2 : SP_2019_RD0108_203_16_20190304_00002.jpg

LM Start	9.66	Rating **	M	Issue No.	16
LM End	9.66	Issue Type +	En	Location *	WS
Category	Earthen Levee			GPS Latitude/Longitude	
				Start	End
Item	Encroachments			38.902691 °	38.902691 °
				-121.914645 °	-121.914645 °
DWR ID	DWR_RD0108_01_f_2016_16				
Comment Code					
ST : Stairway					
Inspector Comment					
Department of Fish and Game staff is using a stairway to access their monitoring site. Unable to verify if a permit exists.

View of stairway look upstream. Fall 2018.

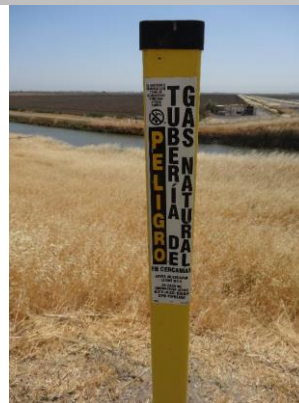
Photo 2 of 3 : UCIP_SP_2019_39717_71704.jpg

LM Start	11.24	Rating **	M	Issue No.	25 (cont)	
LM End	11.24	Issue Type +	En	Location *		
Category	Supplemental			GPS Latitude/Longitude		
				Start	End	
Item	DWR UCIP Field Study			38.925662 °	38.925662 °	
				-121.914303 °	-121.914303 °	
DWR ID	24876					
Comment Code						
Inspector Comment						
FS_ID:39717						
DS_ID:24876						
EP_NO: N/A						
Repair Type: Non-Urgent						
Crossing Status: Indicator Found						
UCIP Comments: Need to contact owner to determine additional details of crossing.						
FIELD_STRUCT_DESC: Natural gas pipeline of an unknown size or material slightly angled through the levee, at an unknown depth. Markers on both sides of the levee. Gas station located across the canal on the landside (LS). This crossing was field discovered.						
FS Date: 3/18/2014

Owner contact information listed on marker.

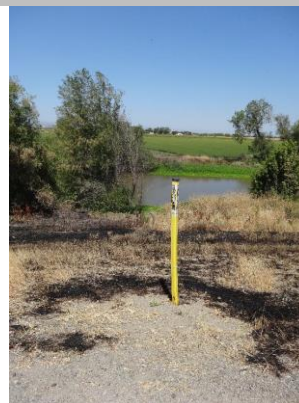
Photo 3 of 3 : UCIP_SP_2019_39717_71703.jpg

Marker visible on waterward side.

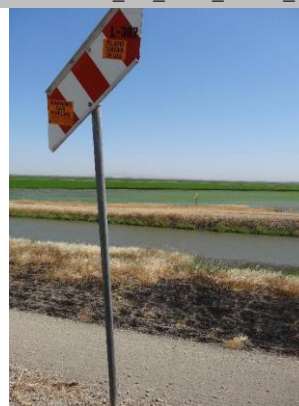
Photo 1 of 3 : UCIP_SP_2019_37623_68246.jpg

Comment Code					
Inspector Comment					
FS_ID:37623					
DS_ID:17942					
EP_NO: 3800					
Repair Type: Non-Urgent					
Crossing Status: Indicator Found					
UCIP Comments: Need to contact owner--marker missing on waterward side.					
FIELD_STRUCT_DESC: 20-inch concrete encased steel natural gas pipeline through the levee, 3 feet below the crown. Crossing appears to be angled through the levee. Small rock revetment on the waterside (WS) slope, unable to locate. Gas well approximately 1000 feet off the landside (LS) toe. (Plans to construct and maintain a 20-inch gas line across the Sacramento River authorized under Permit No. 3800, 1961 - Pacific Gas and Electric Company [PG&E]). [Additional Reference(s): DWR Levee Log, 1991].					
FS Date: 6/10/2014

Marker visible on landward side.

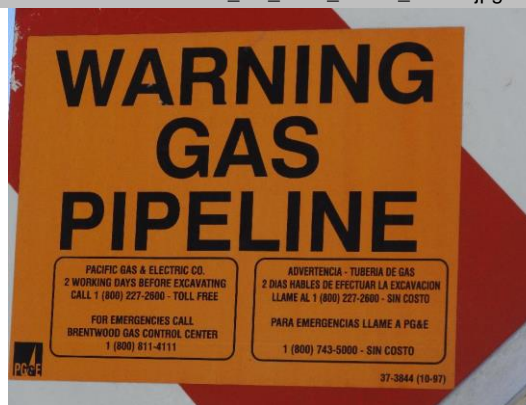
Photo 2 of 3 : UCIP_SP_2019_37623_68245.jpg

Contact information for gas line going through levee.

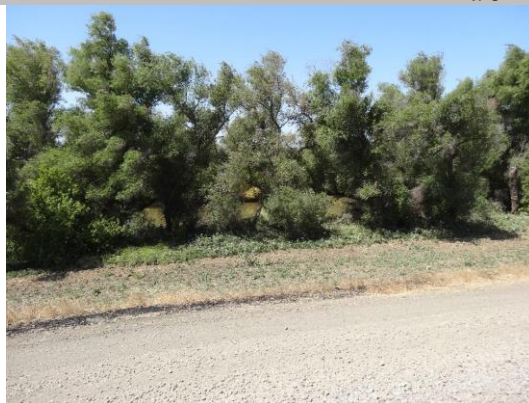
Photo 3 of 3 : UCIP_SP_2019_37623_68244.jpg

Comment Code						
Inspector Comment						
FS_ID:37623 DS_ID:17942 EP_NO: 3800 Repair Type: Non-Urgent Crossing Status: Indicator Found UCIP Comments: Need to contact owner--marker missing on waterward side. FIELD_STRUCT_DESC: 20-inch concrete encased steel natural gas pipeline through the levee, 3 feet below the crown. Crossing appears to be angled through the levee. Small rock revetment on the waterside (WS) slope, unable to locate. Gas well approximately 1000 feet off the landside (LS) toe. (Plans to construct and maintain a 20-inch gas line across the Sacramento River authorized under Permit No. 3800, 1961 - Pacific Gas and Electric Company [PG&E]). [Additional Reference(s): DWR Levee Log, 1991]. FS Date: 6/10/2014

View of waterward side. No marker visible on waterward side.

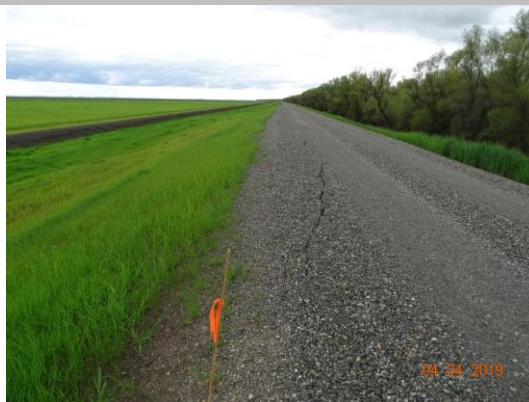
Photo 1 of 1 : SP_2019_RD0108_203_14_20190404_00028.jpg

LM Start	17.30	Rating **	M	Issue No.	14
LM End	17.30	Issue Type +	Ma	Location *	CR
Category	Earthen Levee			GPS Latitude/Longitude	
				Start	End
Item	Cracking			38.995645 °	38.995645 °
				-121.960608 °	-121.960608 °
DWR ID	DWR_RD0108_01_s_2019_14				
Comment Code					
CR2 : Schedule repair of subsidence prior to the next inspection.					
Inspector Comment					
Crown has settled at previous USACE repair site and minor cracking is visible.

View of cracking and settlement on the crown. Spring 2019.

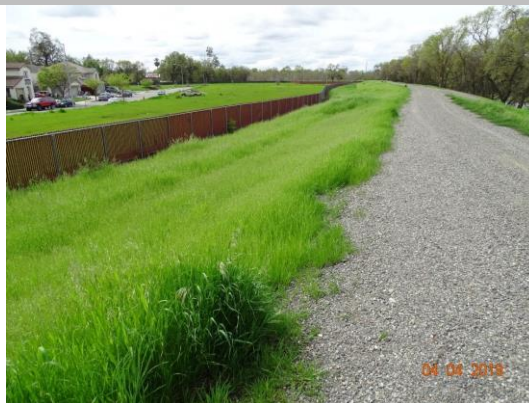
Photo 1 of 1 : SP_2019_RD0108_590_1_20190404_00001.jpg

View of vegetation on the landside slope. Spring 2019.
